Building Inspection Report

45 Sample Report, Ottawa ON

21/11/09

Report Overview

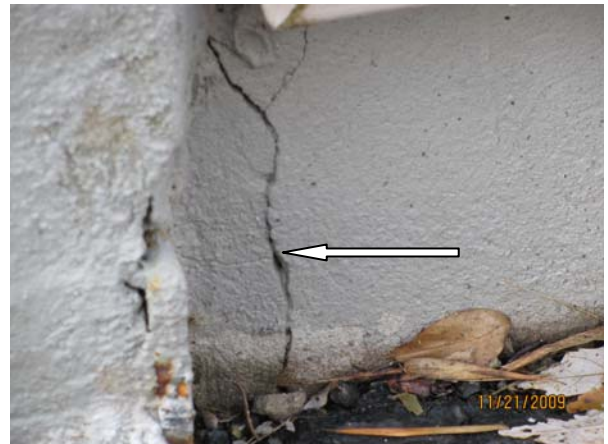
- **Monitor:** Minor cracks (1/8" or less) were noted along the foundation wall in some areas. The amount of movement which has occurred is not likely to have caused other damage to the structure but these areas should be monitored. If the crack widens, have an assessment done by a foundation specialist. If the crack is stable, sealing it effectively may be enough. Do not undertake any insulation or finishing work on the wall until you are satisfied that the crack is perfectly stable, properly repaired and completely sealed against water infiltration. The rate of movement cannot be predicted during a one-time inspection.

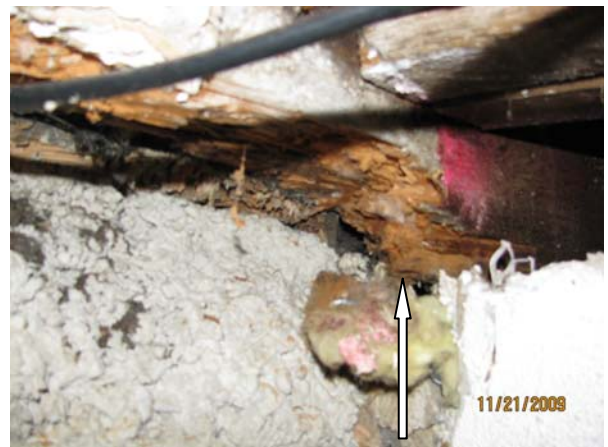
- **Major Concern, Repair:** Some of the wooden structural elements (sills, joists and beams) are decayed and/or suffering from dry rot. This dry rot indicates that the structural elements are in a state of advanced deterioration and may be hazardous for the health of the occupants and risks structural damage. We recommend that structural specialist be contacted to arrange for replacement of the damaged wood. Other areas that may be less affected should be cleaned, disinfected and dried. Ensure that the cause of the problem (water infiltration, poor ventilation, etc) is identified and corrected.

- **Monitor, Repair:** The framing around the stairwell opening does not adequately support the additional load created by the stairwell. There are a number of ways to improve this situation if needed. If sagging or movement in the floor surrounding the stairwell is not excessive, improvements may not be a high priority.

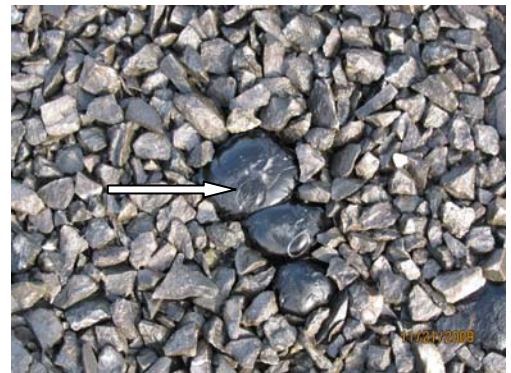
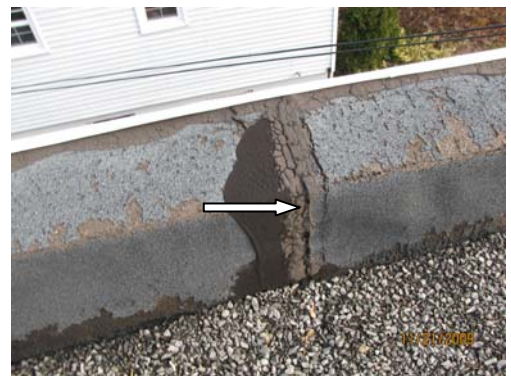
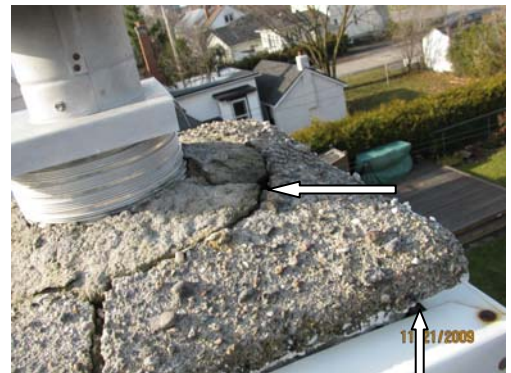
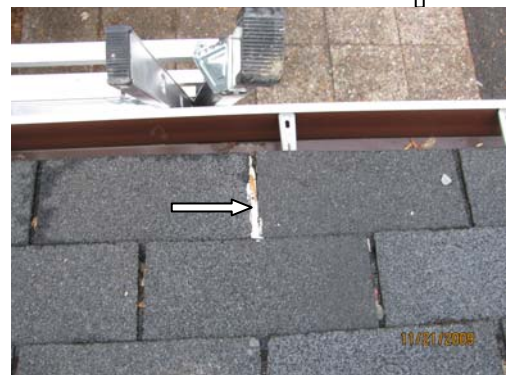
- Repair:** Minor repairs to the rear of house porch roofing are needed. Starter roofing material is improperly installed and should be replaced. All roof penetrations should be examined and properly sealed as necessary.

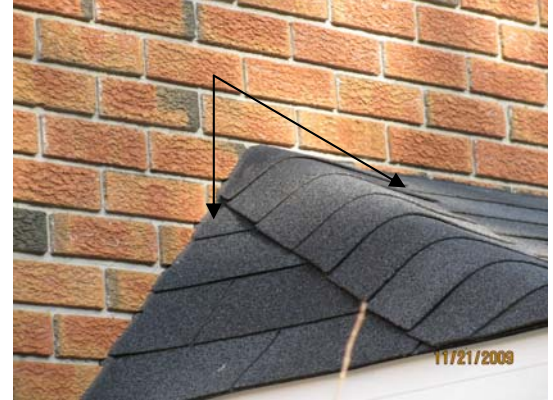
- **Repair:** Missing flashing at porch covering and wall should be replaced to prevent water infiltration/damage.

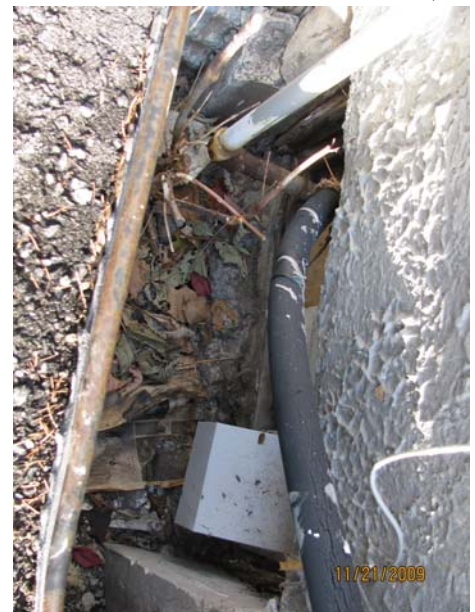
- **Repair:** The perimeter grading slopes towards the structure in one or more areas. This can result in water accumulating around the structure's foundation, or in basements and crawl spaces if they exist. Accumulated water is a conducive condition to wood destroying insects and organisms. Wet soil may also cause the foundation to settle and possibly fail over time, water saturated clay will expand when frozen and could damage foundation walls. We recommend you improve the grading to promote the flow of storm water away from the house. This can often be accomplished by the addition of top soil. The ground should slope away from the house at a rate of one inch per foot for at least the first ten feet. Areas below entrance steps and under decks should also be given special attention. At least six (6) inches of clearance should be maintained between soil level and the bottom of exterior wall siding.

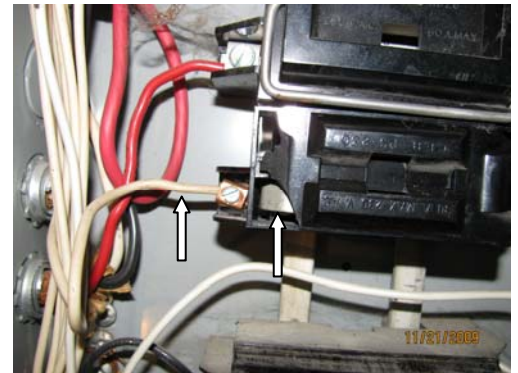
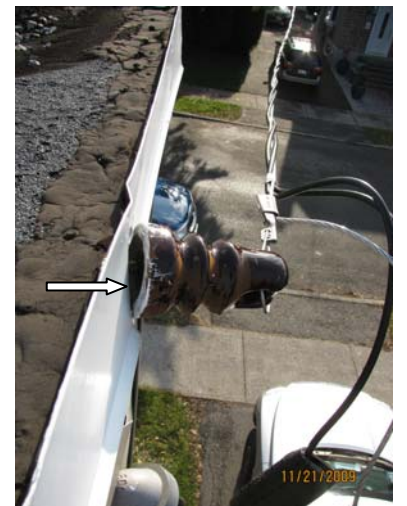
- **Safety Issue:** We recommend replacing the obsolete fused main distribution panel. Double taps, oversized fuses, wires running across the face of bus bars and damaged fuse holders are present / damaged.

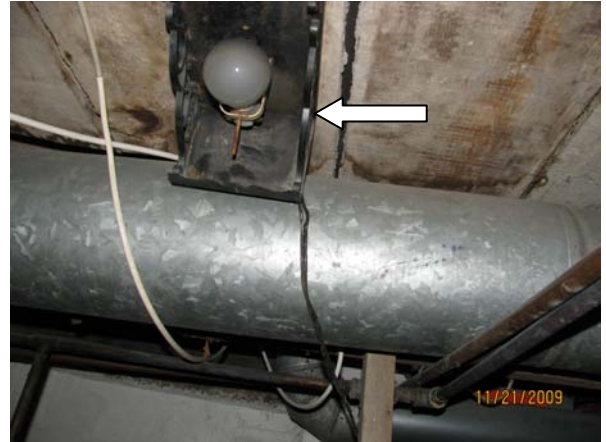
- **Safety Issue:** Improper electrical connections at basement light fixture (in front of electrical panel) should be immediately repaired for improved safety. All electrical connections should be made inside junction boxes fitted with cover plates.

- **Safety Issue:** We observed an extension cord being used as permanent wiring at sump pump and other areas in the home. This represents a potentially safety hazard, as extension cords are not meant to be used in this manner. These cords should be promptly replaced with safer, permanent wiring of an appropriate type. Depending on your electrical needs, it may be necessary to run new wiring for additional outlets.

- **Safety Issue:** The buried cable to the detached garage is not suited to this application. It should be replaced with wiring suitable for use underground.

- **Safety Issue:** Loose dryer receptacle should be secured.

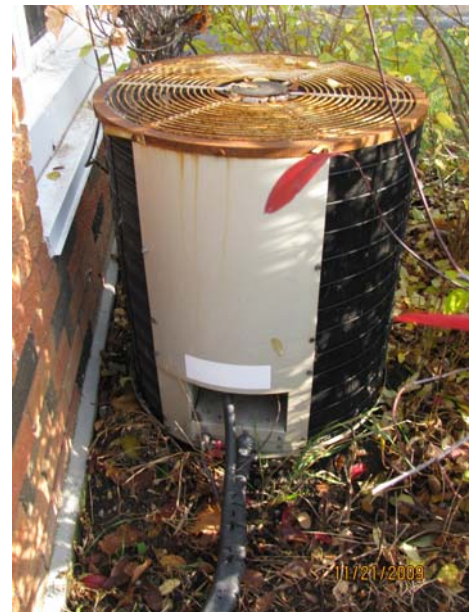
- **Major Expense:** As is not uncommon for homes of this age and location, the air conditioning system is old. It may be more prone to major component breakdown. Predicting the frequency or time frame for repairs on any mechanical device is virtually impossible.
- **Improve:** Vegetation in the vicinity of the outdoor unit of the air conditioning system should be cut back.
- **Improve:** Damaged insulation on refrigerant lines should be repaired.

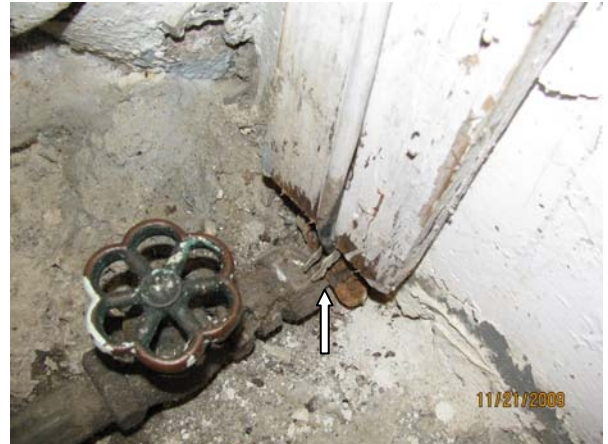
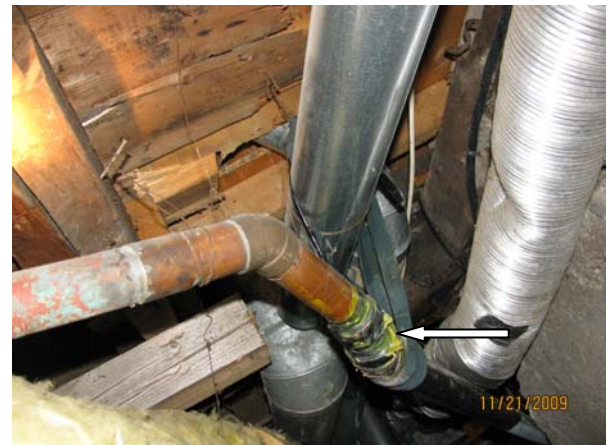
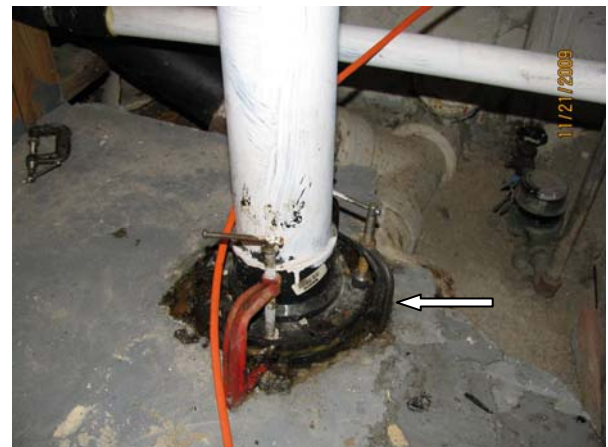
- **Repair:** We observed evidence of less-than-professional workmanship with the installation and/or repairs on the drainage piping in some areas. Drains with negative slope (slopes up hill) should be reconfigured with a proper slope in the pipe to prevent clogging. Piping support and connections should be improved in some areas in basement.
