Building Inspection Report

45 Sample Report, Ottawa ON

21/11/09

Report Overview

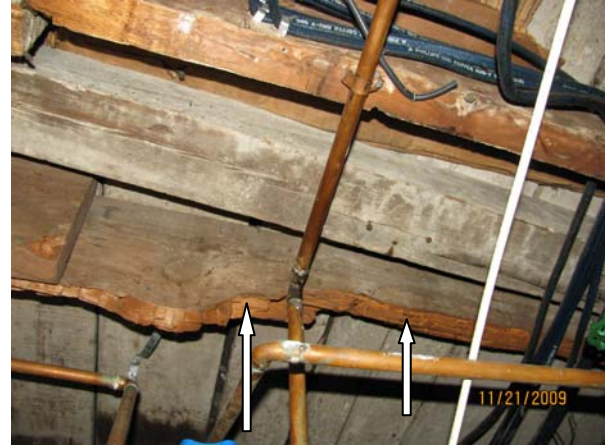
- **Major Concern, Repair:** Some of the wooden structural elements (sills, joists and beams) are decayed and/or suffering from dry rot. This dry rot indicates that the structural elements are in a state of advanced deterioration and may be hazardous for the health of the occupants and risks structural damage. We recommend that structural specialist be contacted to arrange for replacement of the damaged wood. Other areas that may be less affected should be cleaned, disinfected and dried. Ensure that the cause of the problem (water infiltration, poor ventilation, etc) is identified and corrected.

- **Monitor, Repair:** The framing around the stairwell opening does not adequately support the additional load created by the stairwell. There are a number of ways to improve this situation if needed. If sagging or movement in the floor surrounding the stairwell is not excessive, improvements may not be a high priority.

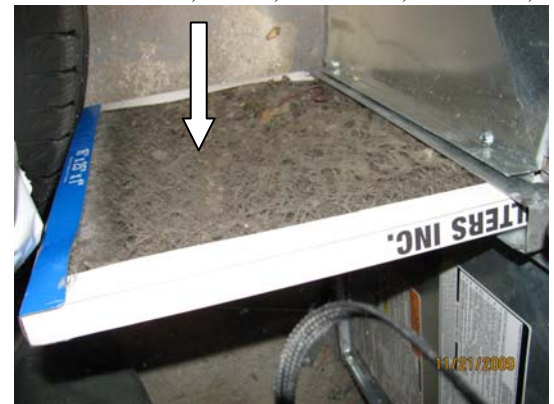
The heating system appears to be in generally good condition; the gas furnace is dated 2005. Adequate heating capacity is provided by the system.
